## Inspection Report Minerals Regulatory Program

Mine Name: Black Butte Operator Name: GoldTerra

Permit number: S0150080 Inspection Date: October 16,

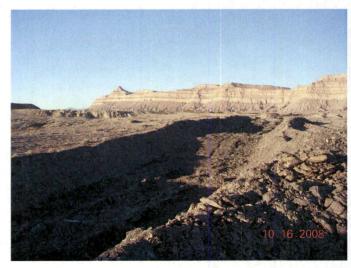
Photo 1. This and Photo 2 show two of the trenches.

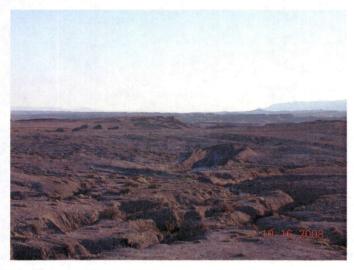
Photo 3. The piles across the center of this photo are associated with trenches.
